File: 04-ALA-580 PM 5.0
04-1SS030
EFIS# 0400020869-0
North Flynn Road
Soldier Beam Wall with
Ground Tieback Anchors
Storm Damage

Subject: **REVISED FOUNDATION REPORT**

This Foundation Report (FR) supersedes our June 2, 2014 FR recommendations for the repair of the roadway distress and slope failure located on westbound of the State Route 580 PM 5, close to Livermore, Alameda County (see Figure 1).

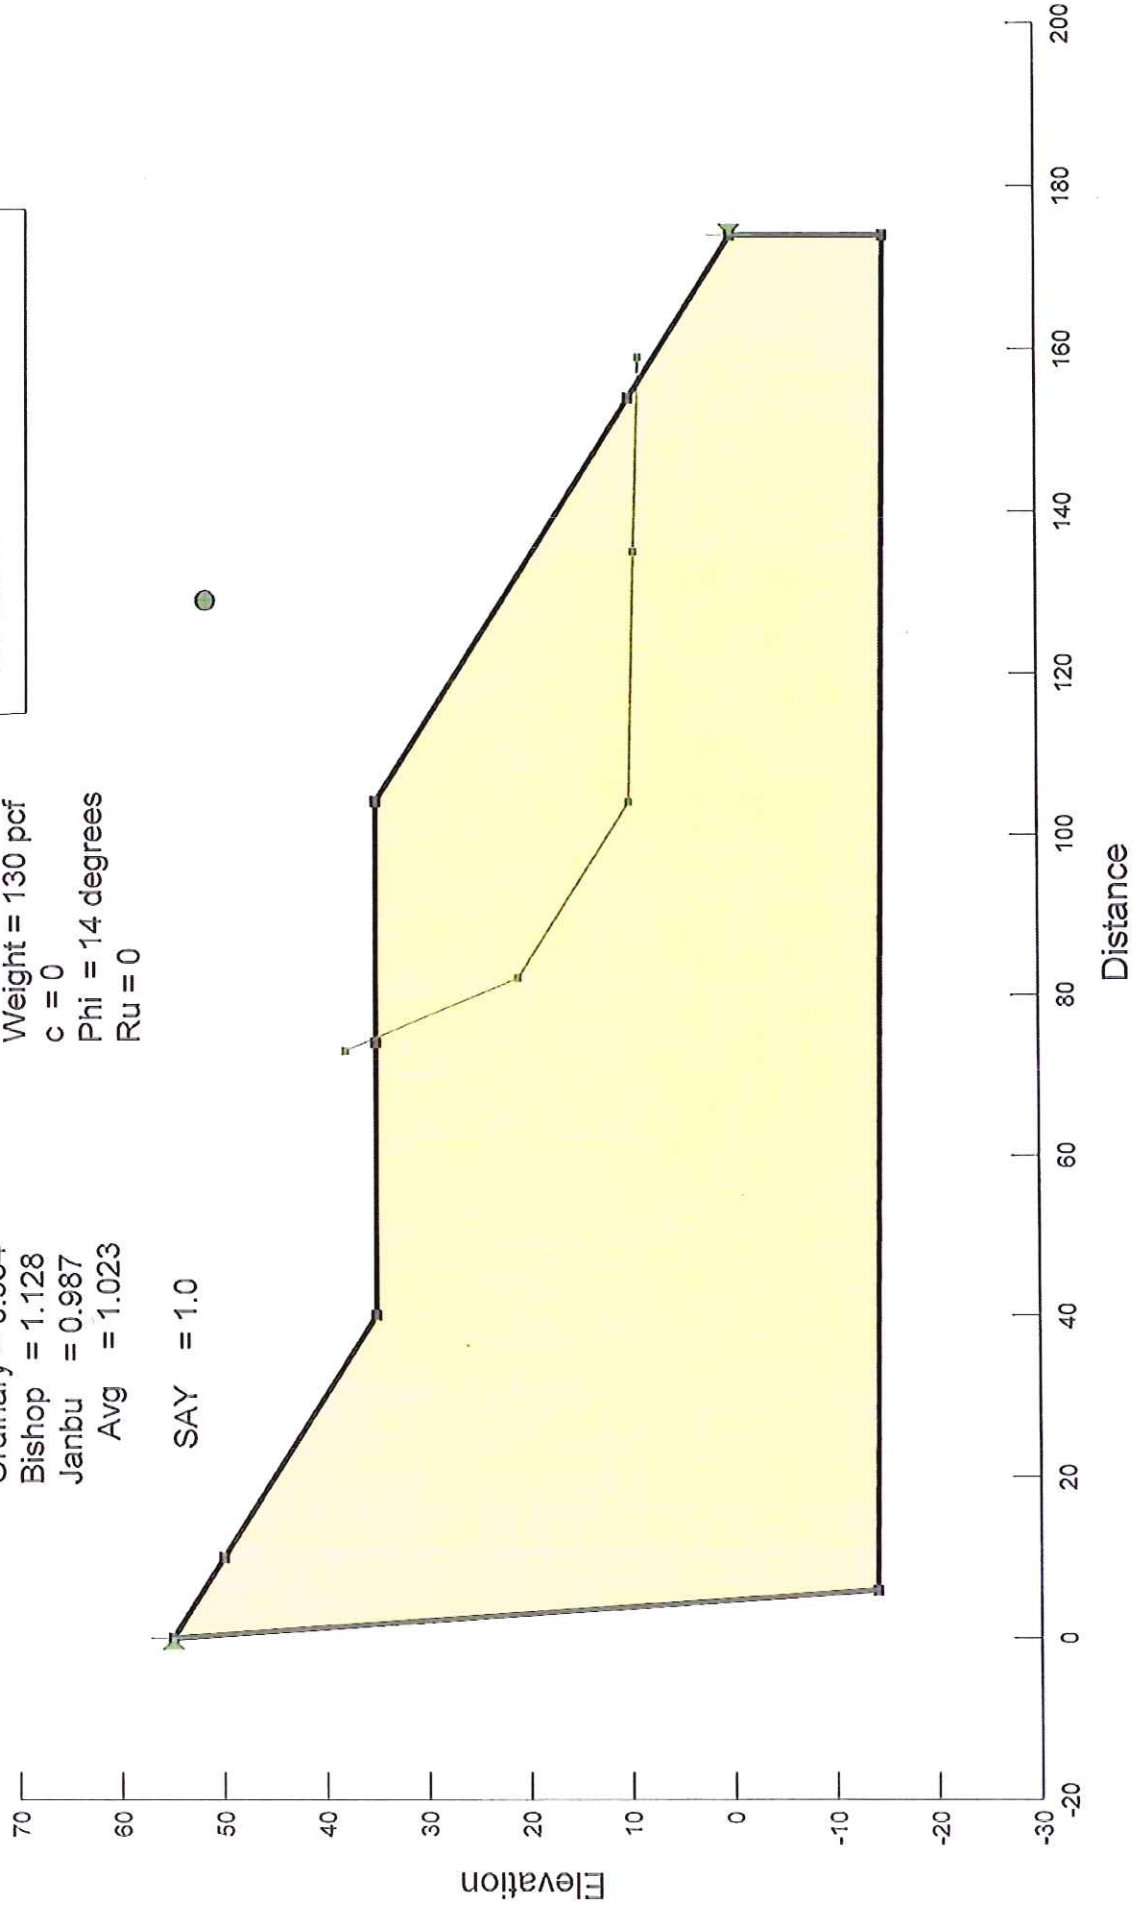
Soil/rock strength parameters of the sliding mass were determined using back-analysis of the landslide. This is necessary because it is impractical to estimate the residual shear strength of the soil/rock at the slip-plane by conventional methods. The size of the sliding mass was estimated using slip-plane location based on the SIs data, measured head scarp location, and other geologic features. Our back analysis show that slide soil material in dry condition has an effective friction angle of 14° and cohesion of 0 psf (along the slip-plane) for SF of 1.0. To

Weight = 130 pcf
 $c = 0$
 $\Phi = 14$ degrees
 $R_u = 0$

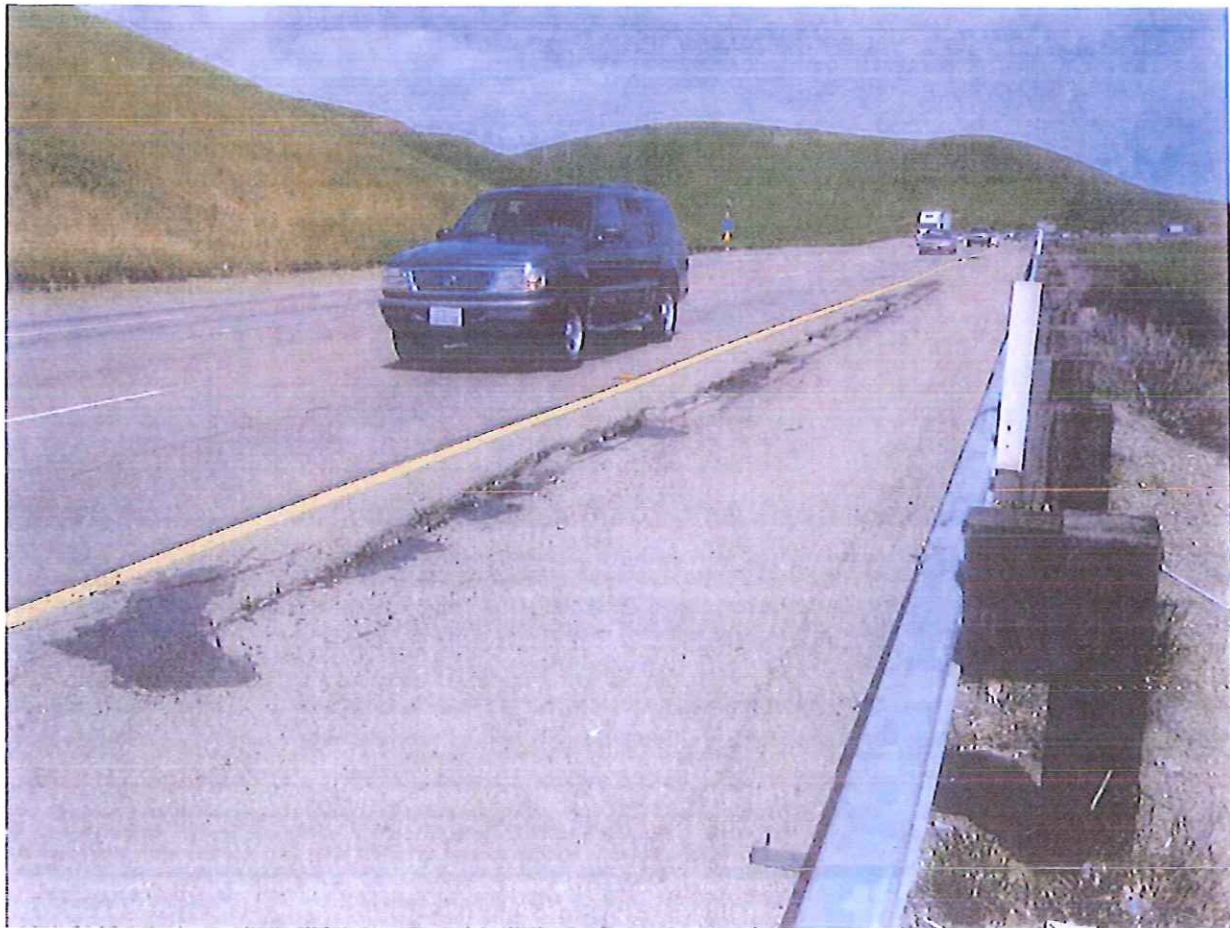
Looking east on WB I-580, Postmile 5.0 – pavement cracking in the shoulder adjacent to the Number 1 lane.

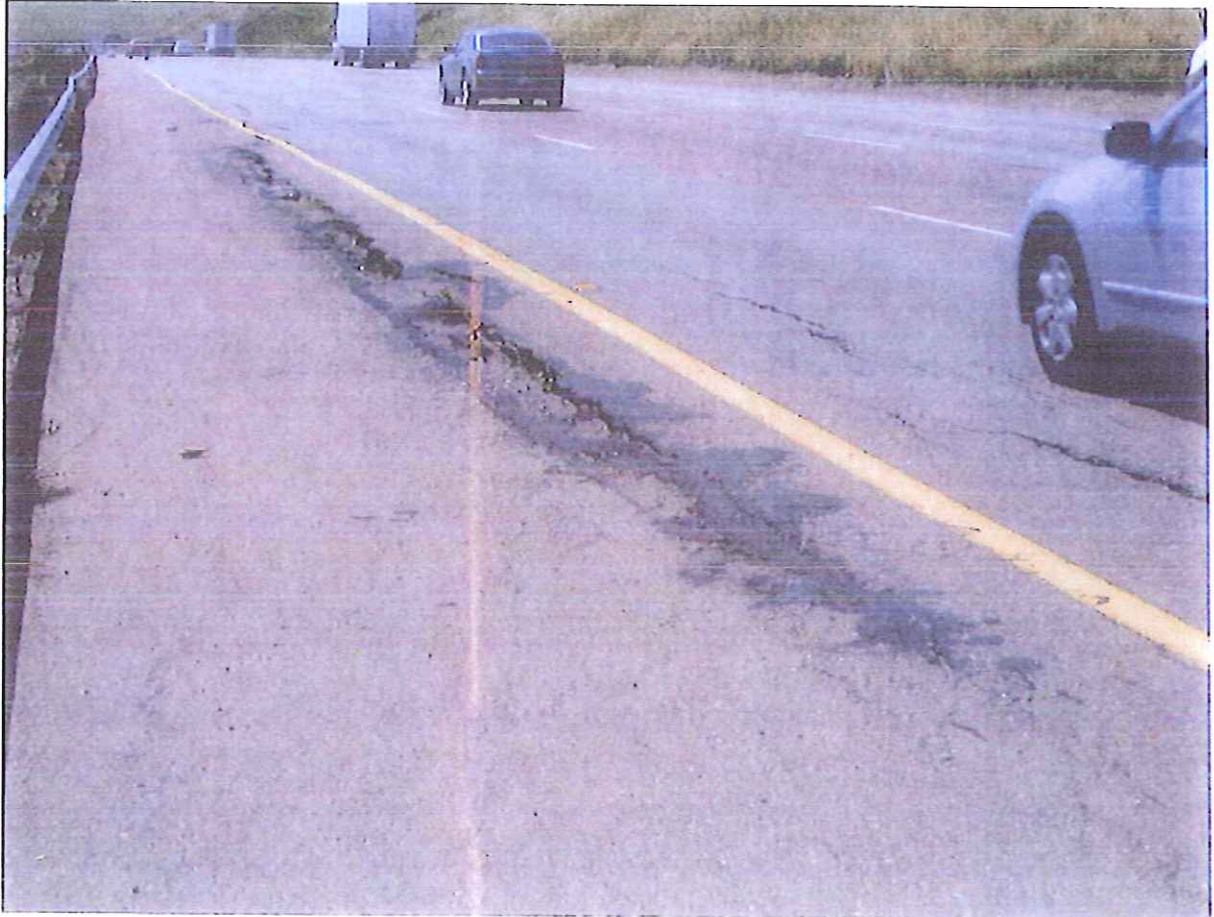
Looking west on WB I-580, Postmile 5.0 – pavement cracking in the shoulder adjacent to the Number 1 lane.

The current project consists of constructing a retaining wall to restrain the slope.

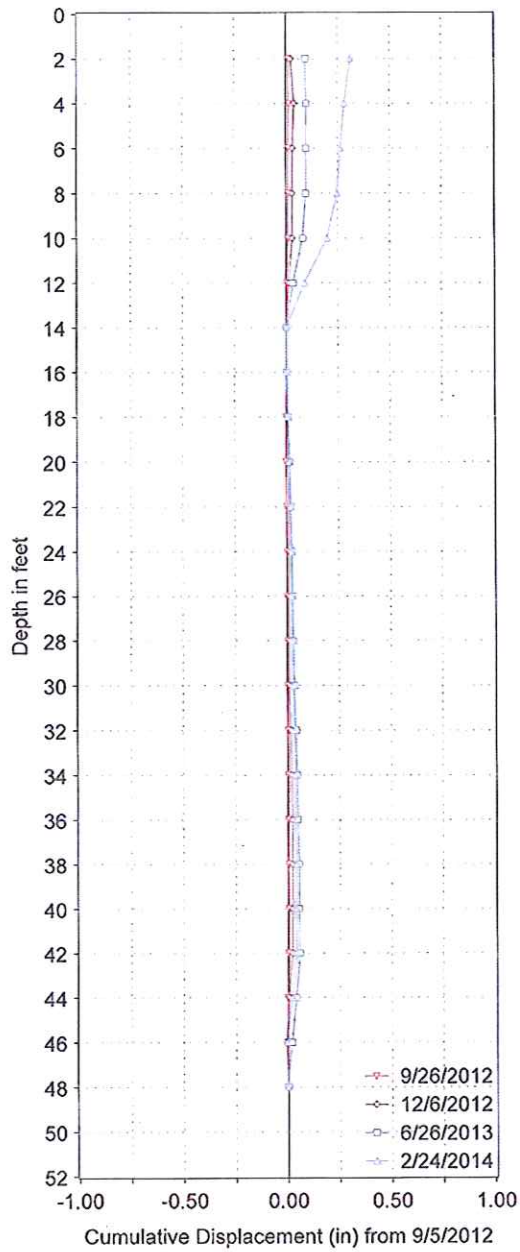
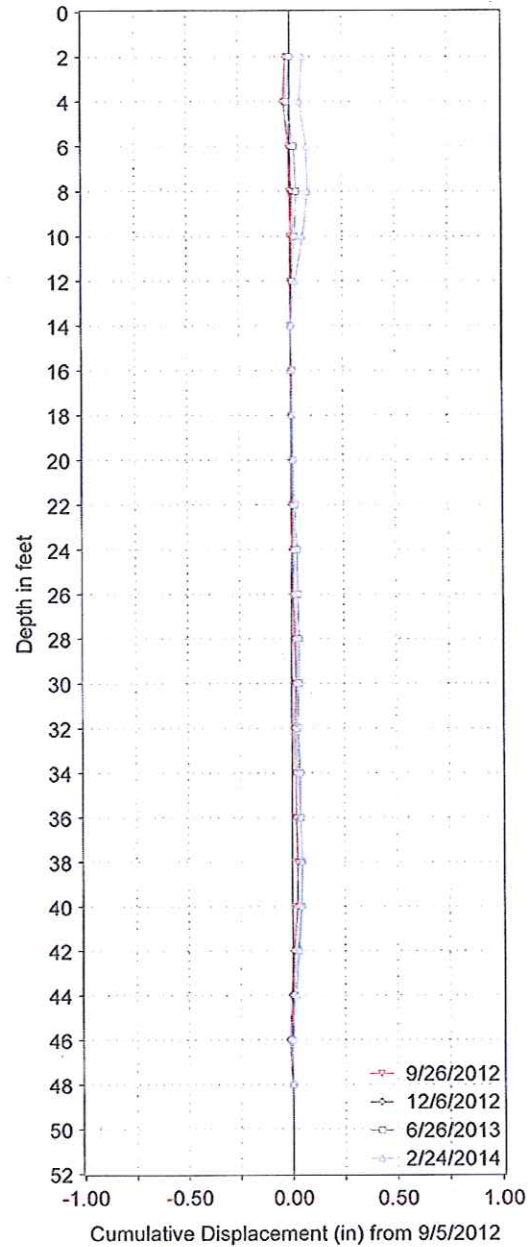
NFLYNN RW002, A-Axis

Boring RW-12-001 was drilled to a depth of 75-ft. Boring RW-12-002 was drilled to a depth of 50-ft and a slope inclinometer (SI-1) was installed. Boring RW-12-003 was drilled to a depth of 50-ft. and a slope inclinometer (SI-2) was installed. Boring RW-12-004 was drilled to a depth of 70-ft, and a slope inclinometer was installed. The slope inclinometers have been modified to allow for piezometric readings.
